**RE: Report on NRG Greenboard™ Cladding Fixing Requirements**

NRG Greenboard™  
Cladding Fixing Requirements  
TESTING REPORT

# SCREW PULLOUT TEST REPORT

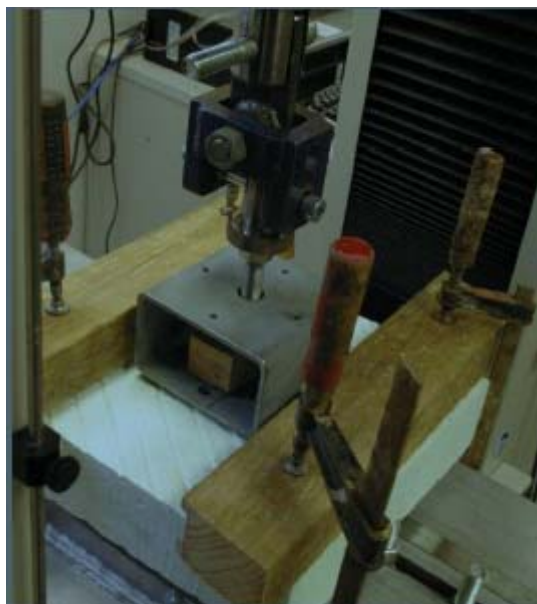
The test rig used is shown below.

The samples were tested by placing them into the testing machine. The samples were loaded until failure and logged with an electronic data collection system.

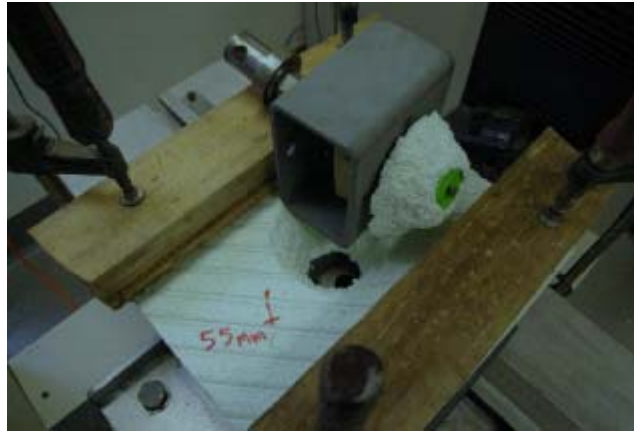
All of the samples were noted to fail with fastener withdrawal through the panel being the mode of failure.

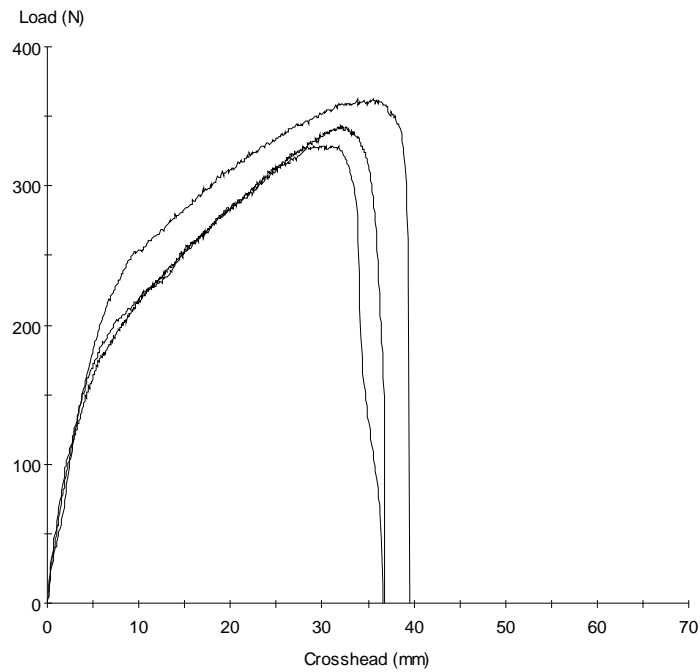
**Load vs Extension Plot**

**Specimen Results: 55mm Thick Samples**

<b>Specimen #</b>	<b>Peak Load N</b>	<b>Failure Mode</b>
1	363	Washer pull-thru foam
2	343	Washer pull-thru foam
3	329	Washer pull-thru foam
<b>Mean</b>	<b>345</b>	-
<b>Std Dev</b>	<b>17</b>	-

The mean ultimate load reached for the samples was 345N as determined by the failure of the EPS. The standard deviation of the samples was 17N with a coefficient of variation of 5% giving  $k_t=1.15$  and a capacity of  $345/1.15=300N$ .

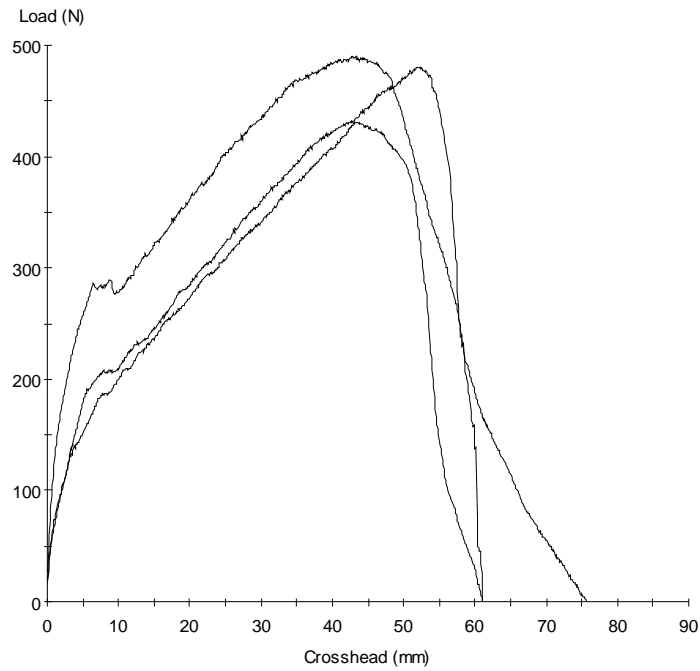
**Load vs Extension Plot**

**Specimen Results: 73mm Thick Samples**

Specimen #	Peak Load N	Failure Mode
1	480	Washer pull-thru foam
2	490	Washer pull-thru foam
3	432	Washer pull-thru foam
<b>Mean</b>	<b>467</b>	-
<b>Std Dev</b>	<b>31</b>	-

The mean ultimate load reached for the samples was 467N as determined by the failure of the EPS. The standard deviation of the samples was 31N with a coefficient of variation of 6.7% giving  $k_t=1.21$  and a capacity of  $467/1.21=385N$ .

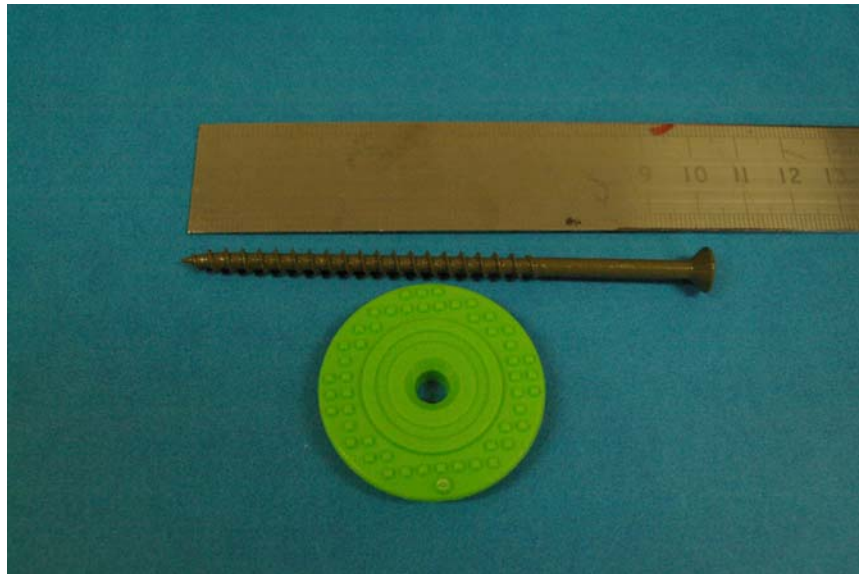
**Photograph 1 – Screw and Washer used for test**

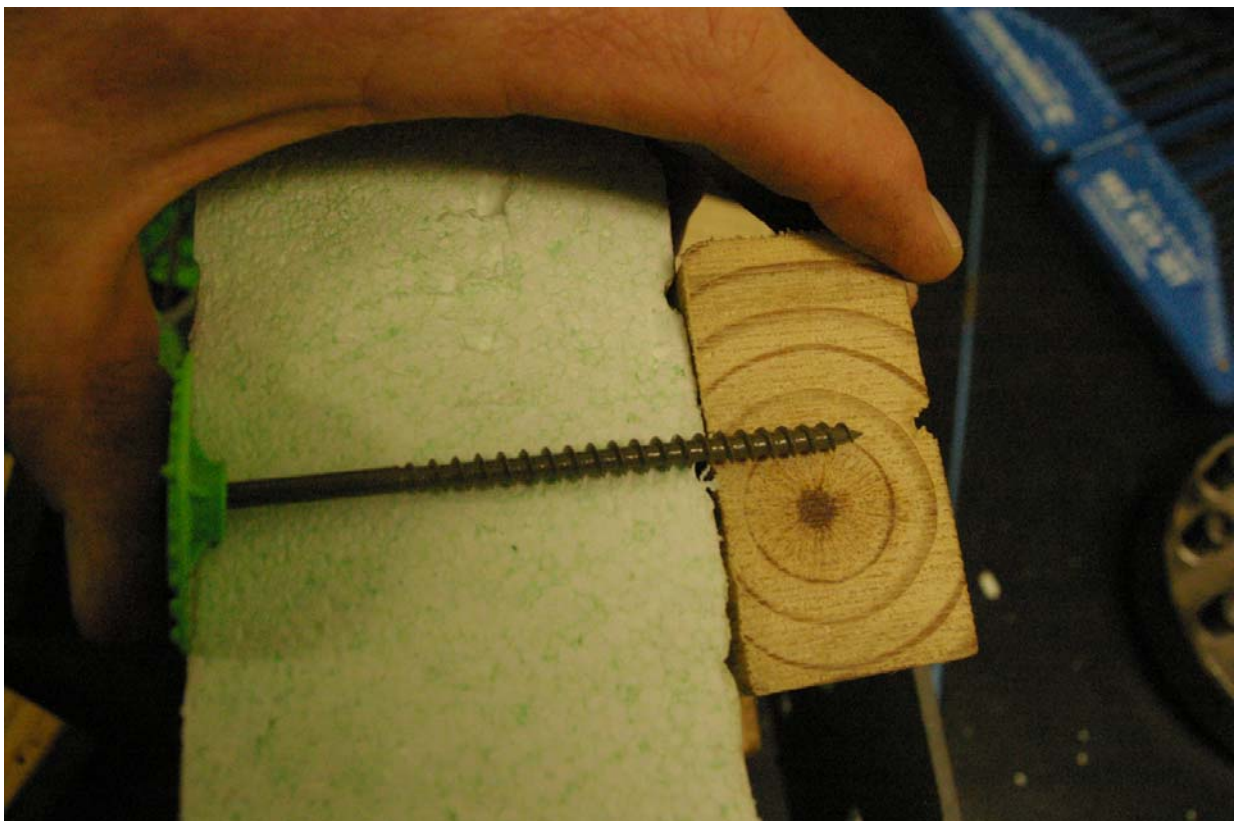
**Photograph 2 – Showing screw length (73mm thick sample)**

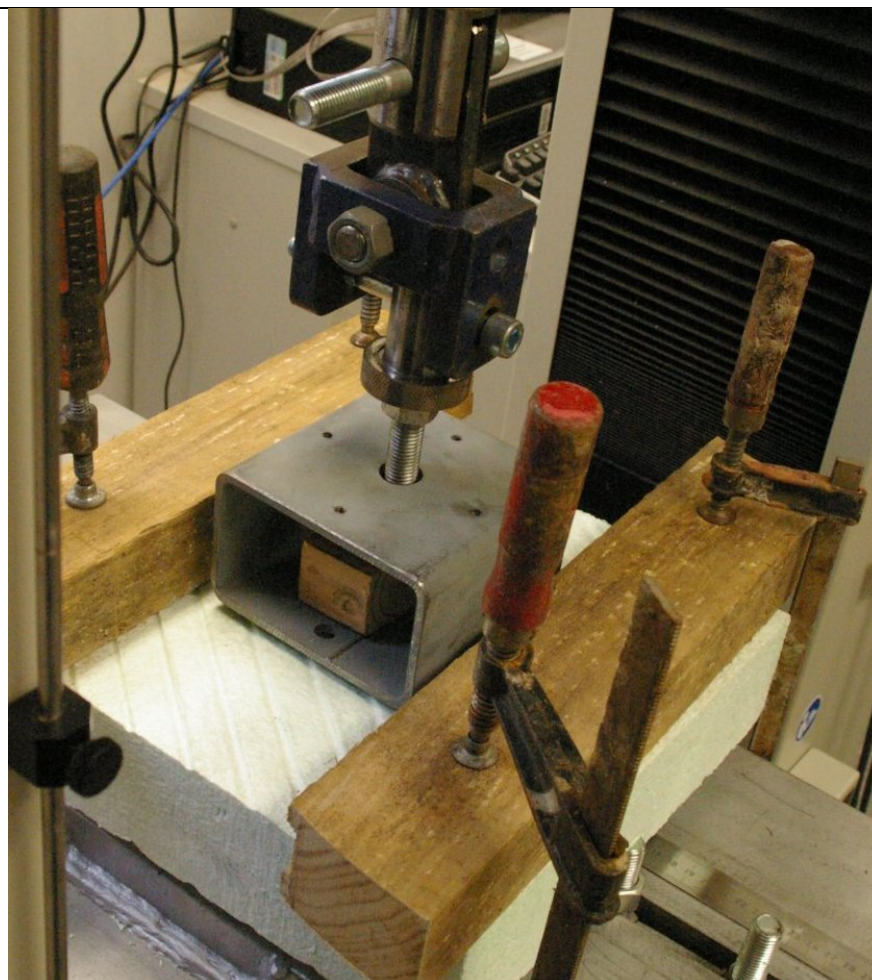
**Photograph 3 – Typical test setup**

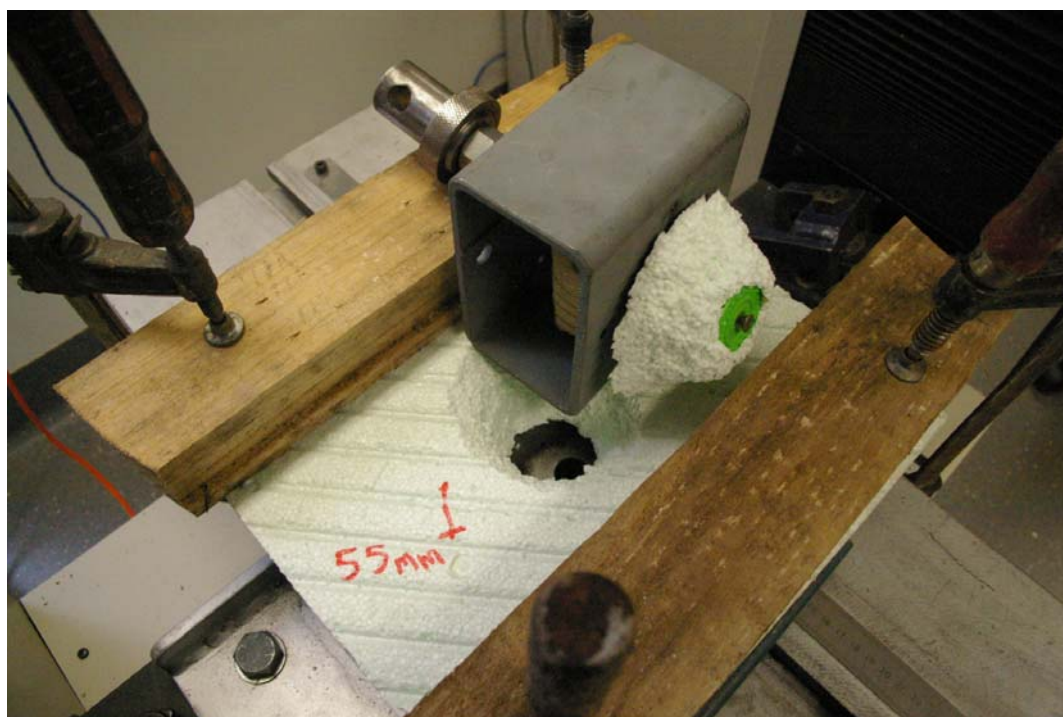
**Photograph 4 – Typical failure mode**
